WASHINGTON COUNTY OFFICE OF PLANNING AND ECONOMIC DEVELOPMENT
 115 GEORGETOWN AVENUE, WASHINGTON COUNTY, NY 12153

FIRST FLOOR DEMOLITION PLAN

FIRST FLOOR CONSTRUCTION PLAN

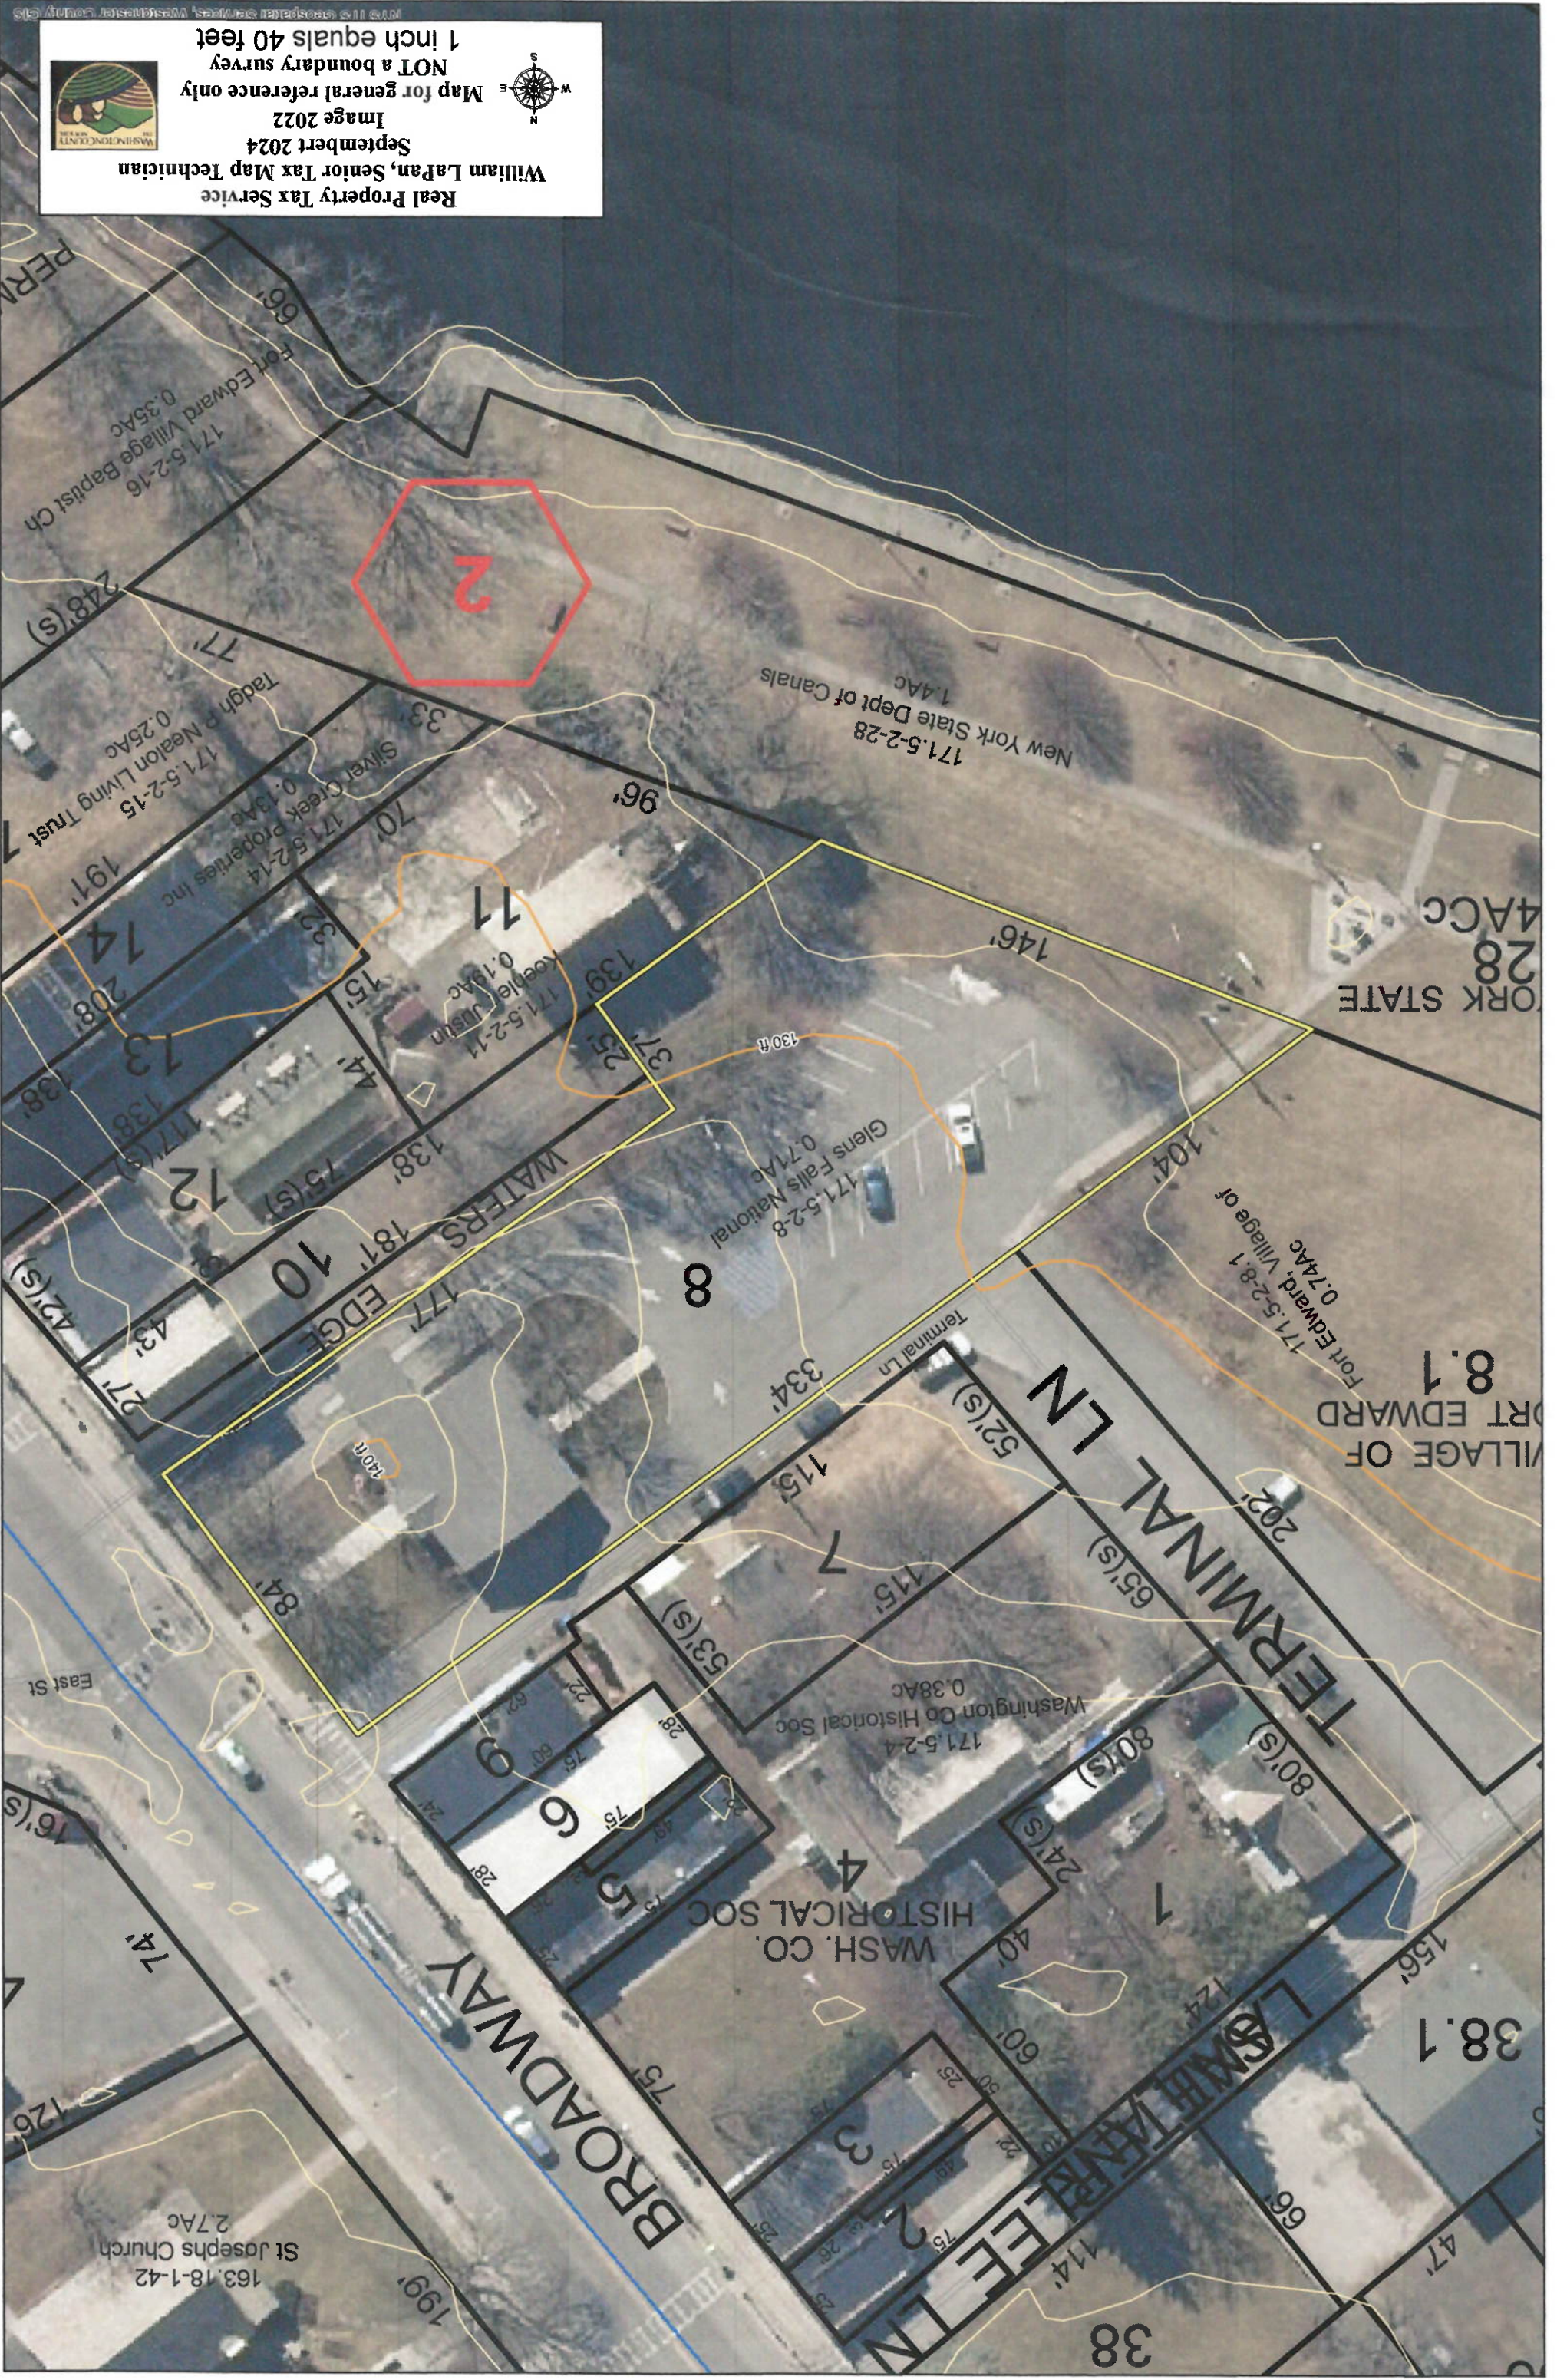
36" HANDICAP ACCESSIBLE SINK AND COUNTER

CONSTRUCT 2x4 STUD WALL, PAINT GRADE FINISH
36" HANDICAP ACCESSIBLE DOOR

FABRICATE A STOP TO BE MOUNTED TO THE FLOOR TO
PREVENT THE VAULT DOOR FROM BEING CLOSED

REPAIR CEILING IN SERVICE AREA TO MATCH

CONSTRUCT 2x4 STUD WALL DINING ROOM/SERVICE AREA
WILL BE A PAINTED FINISH- THE KITCHEN WILL BE FRG SYSTEM

ADD STAINLESS WALL PANELS WITH SEAM STRIPS AND
AND END CAPS BEHIND COOKING EQUIPMENT

ADD STAINLESS WALL PANELS WITH SEAM STRIPS
AND END CAPS BEHIND COOKING EQUIPMENT

REPAIR CEILING IN KITCHEN AREA TO MATCH EXISTING
